# CARBON FOOTPRINTING AND ENERGY EFFICIENCY AUDIT

## Alresford Golf Club

Produced on Behalf of The R&A, EGU and GUW

JANUARY 2010

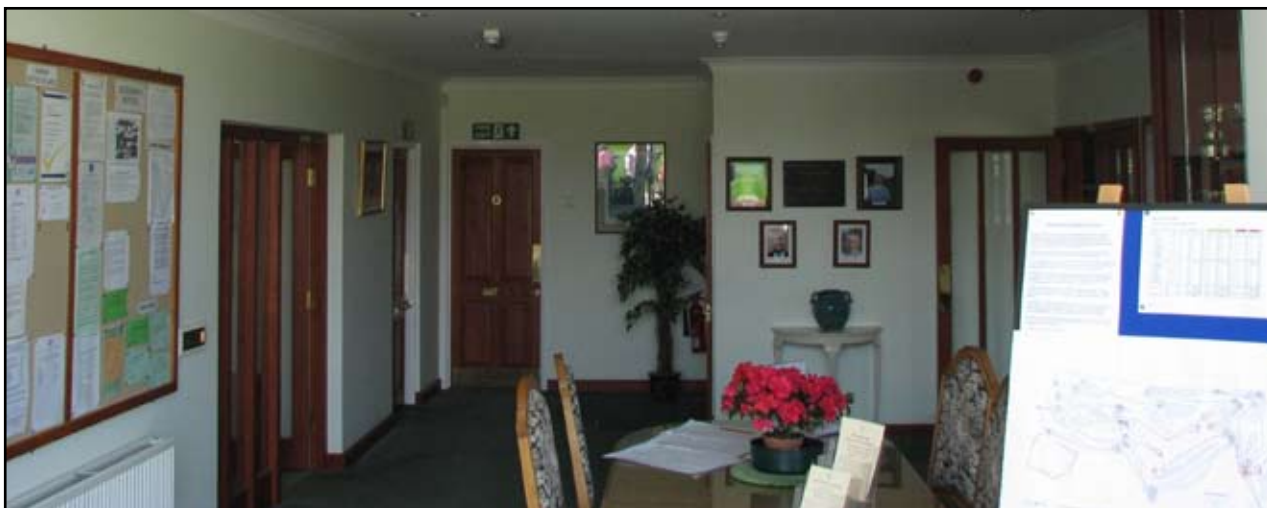
The club have been proactive in testing different lighting methods and have replaced the former halogen bulbs in the foyer with low energy LED spot lights, effectively reducing the electricity use in this area around tenfold. However, the entrance foyer has glass walls and high windows which provide excellent natural light, yet all the lights in this area were observed to be on during the visit, despite dry sunny conditions outside. The lights in the foyer and hallway can be controlled differentially and therefore only the hallway lights may be required to be on when outside light conditions are good.

All windows in the foyer are double-glazed but the roof space is high with no insulation and much heat is lost from the foyer. The installation of a second set of internal doors between the entrance foyer and the main entrance hall would help to conserve heat in the main entrance hall in winter and also help keep the main hall cool in summer.

| Issue | Potential solutions |
|---|---|
| Inefficient lighting types and lighting use | Change halogen spotlights to LED lights and turn off lights in entrance foyer on bright days. |
| Loss of heat from hallway through doors and windows of entrance foyer | Installation of a set of internal doors between foyer and hallway |

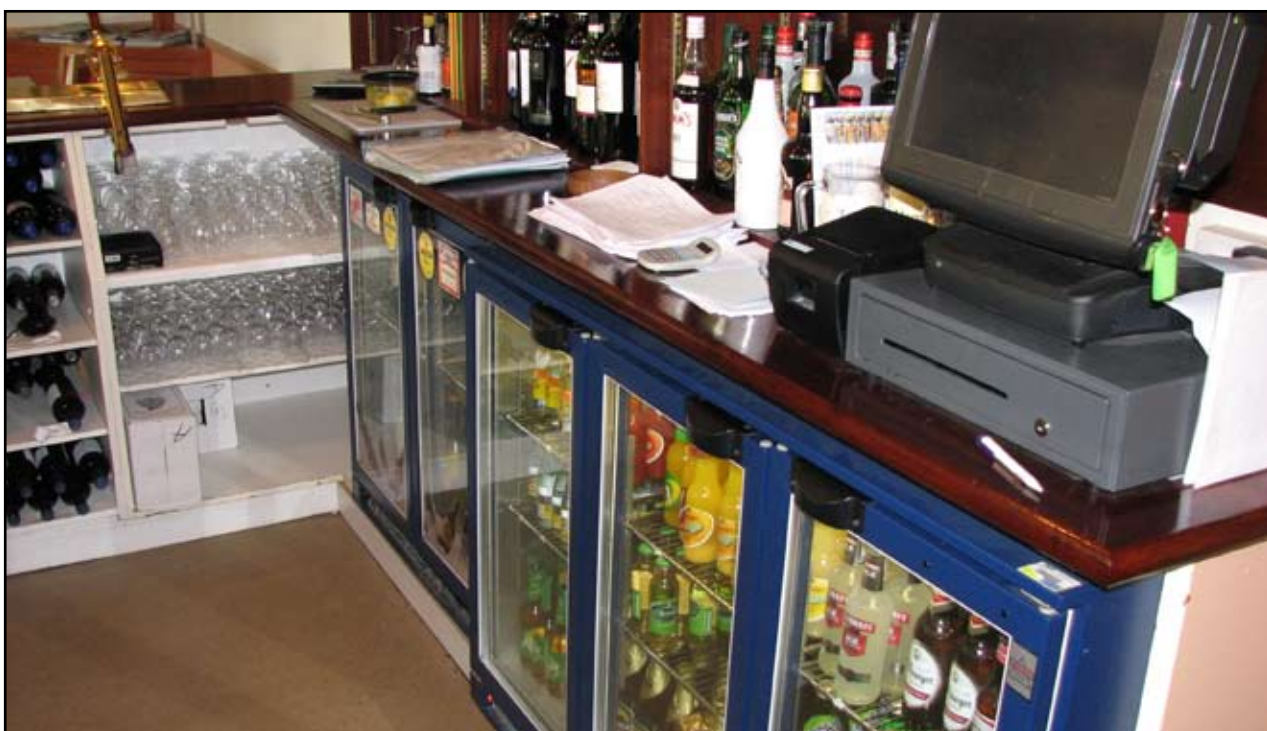
In addition, the lights in the bar and lounge are differentially controlled but more specific controls that would allow different sets of lights in the lounge area to be isolated would be beneficial to stop lights being turned on when not required.

Several radiators in the lounge area were partially blocked by the lounge chairs, which will absorb the heat and prevent circulation of heat around the room. Care should be taken to arrange furniture away from radiators to increase the efficiency of the heating system. The curtains in the lounge should be closed after dark to reduce heat loss.

| Issue | Potential solutions |
|---|---|
| Bottle cooler equipment on when not required | Install timer switches on plug points |
| Lack of control over lighting in lounge area | Install differential controls for lights |
| Radiators blocked and operating inefficiently | Rearrange furniture away from radiators |

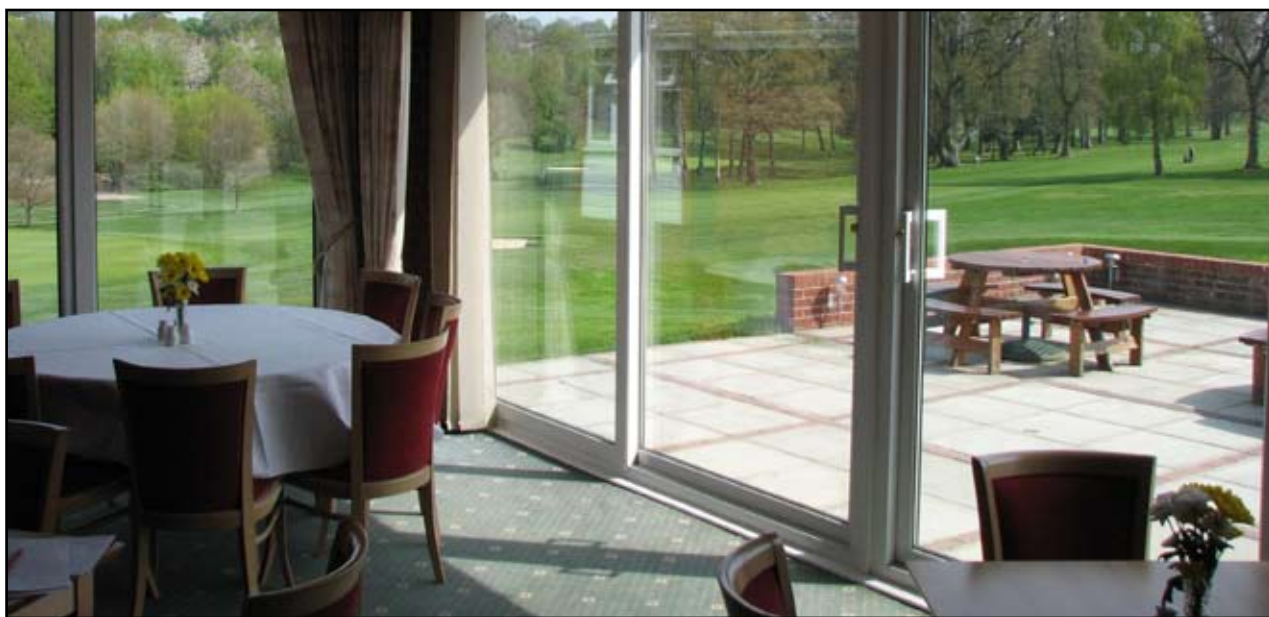
The ceiling in the dining room is high with no insulation and there are eight large windows in the room. This means that the room will lose heat easily in winter and may overheat in summer. The ceiling height could possibly be reduced to allow the introduction of insulation above, though the skylight in the room may make this more difficult. The curtains in this room should be closed at night, particularly in winter, to reduce heat loss. The internal doors between the dining room and lounge area will also help to reduce heat loss from the lounge through the poorly insulated dining room and should be closed when possible.

The only electrical items in the dining room are the ceiling lights. These are currently incandescent bulbs and should be replaced with low energy lights to reduce electricity use throughout the year.

| Issue | Potential solutions |
|---|---|
| Inefficient lighting | Replace incandescent bulbs with compact fluorescent bulbs |
| Roof poorly insulated and high number of windows leading to high heat loss | Consider installing roof insulation<br>Close curtains at night to reduce heat loss and close internal doors between dining area and lounge when lounge not in use |

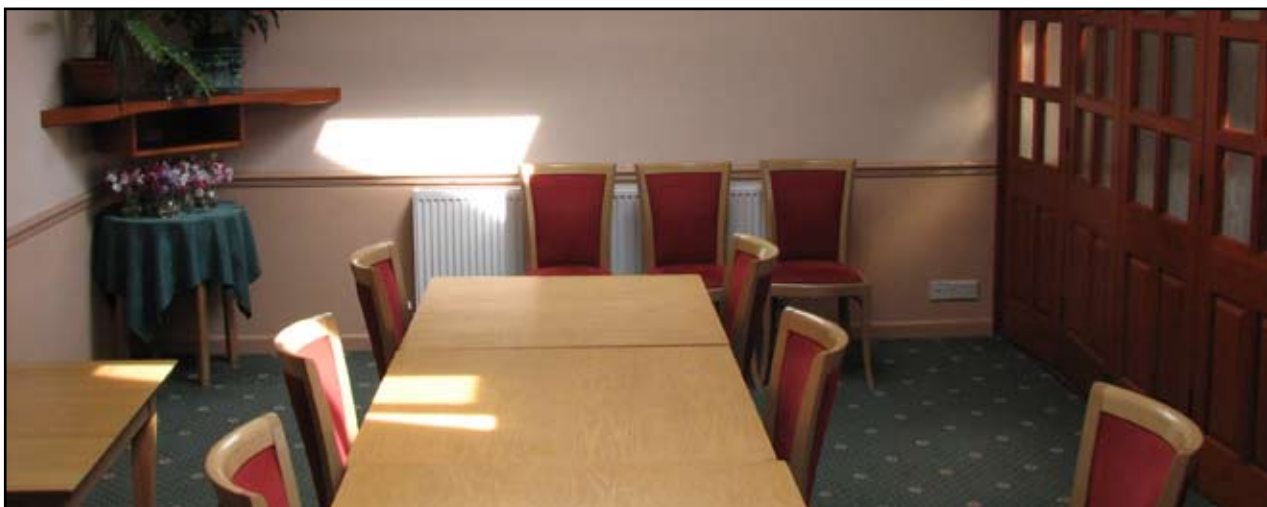
The meeting room has a lower ceiling than the dining room which and is therefore assumed to be insulated. There are several items of electrical equipment such as a CD player, tuner, cassette deck, amplifier and VHF receiver. These items are very infrequently used and generally have a low wattage. The lights in the room are a mix of energy efficient compact fluorescent bulbs and incandescent bulbs. The incandescent bulbs should be replaced when possible.

As in the lounge, the radiators in the meeting room were blocked by chairs and care should be taken to ensure that furniture is positioned away from radiators to permit heat to circulate around the room. The partition doors between the meeting room and the lounge are poorly fitted allowing heat to transfer between the two rooms and making it more difficult to heat the lounge which is the more frequently used space.

| Issue | Potential solutions |
|---|---|
| Radiators blocked and operating inefficiently | Rearrange furniture away from radiators |
| Inefficient lighting | Replace incandescent bulbs with compact fluorescent bulbs |

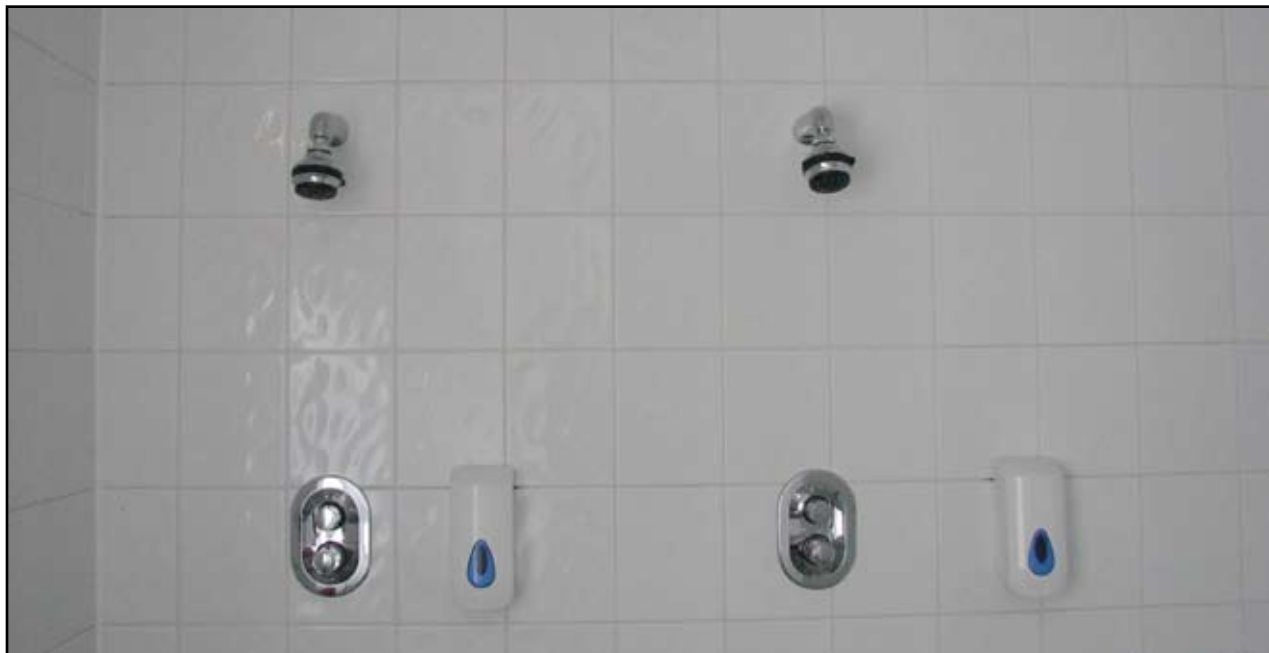
Table 3 (Appendix 1) lists the electrical equipment within the ladies and gents locker room and demonstrates that the showers in each locker room (assumed to be electric showers) are by far the main energy users, followed by the halogen lighting. The use of showers can probably not be greatly reduced, though members could be made more aware of the high energy cost of the showers by placing notices in the locker rooms. The lighting costs could be

reduced by replacing the 40 w halogen bulbs in each room with low energy LED bulbs, reducing the annual cost tenfold from an estimated £295 to £29.

| Issue | Potential solutions |
|---|---|
| Heating on and windows open | Use individual thermostatic controls on radiators to control the room temperature. Check controls periodically to correct any alterations. |
| High lighting costs | Replace halogen bulbs with low energy LED bulbs |
| Water use | Install bricks or 'hippo' devices within toilet cisterns to reduce water use for toilet flushing<br>Consider rainwater harvesting to provide water for flushing toilets |

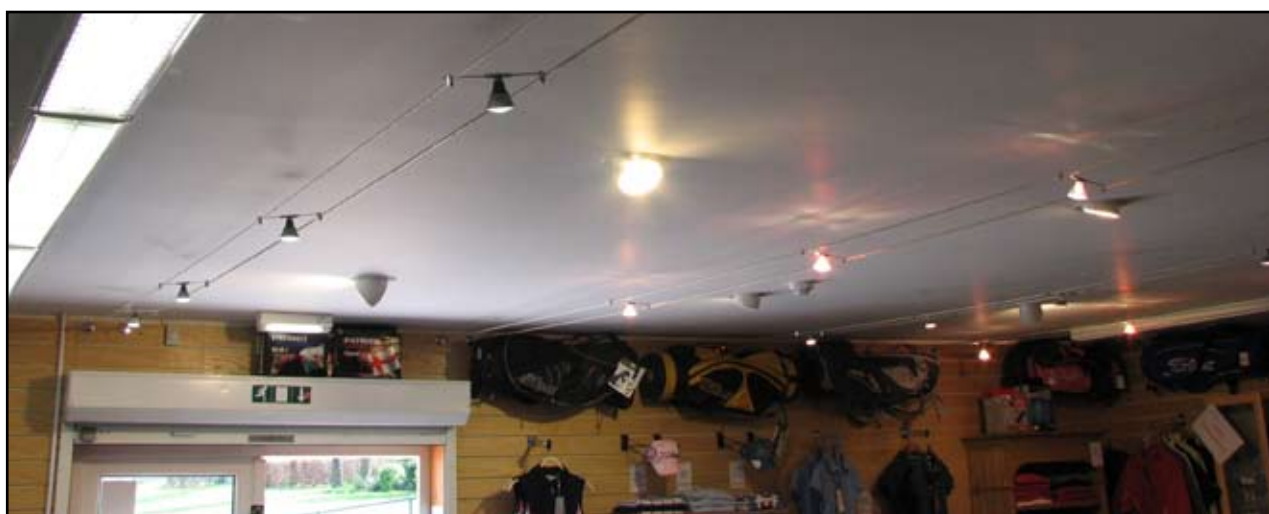
The Pro shop consists of a main shop display area and an office and stock room. The Pro shop requires a lot of light to showcase the golfing products on sale and Table 5 (Appendix 1) illustrates that the lights in the Pro shop account for the highest consumption of energy in the Pro shop throughout the year. The club are currently trialling different lighting systems in the pro shop to evaluate their performance and the variation in energy consumption for the three main lighting methods (fluorescent strip lights; halogen spot lights and LED spot lights) can be compared in Table 7, which shows the much lower cost of running the LED lighting system. However, LED bulbs and halogen bulbs should not be mixed in the same lighting array and a new transformer may be required to ensure compatibility with the LED lights and this adds to the cost of the LED bulbs.

The seven battery chargers which are used to charge trolley batteries also consume a significant amount of electricity each year. The calculation in Table 7 assume that each battery charger is in constant use and switching off the battery chargers when not in use could bring amount significant savings throughout the year.

| Issue | Potential solutions |
|---|---|
| Inefficient lighting | Replace inefficient lighting types with best performing lighting systems at end of trial period |

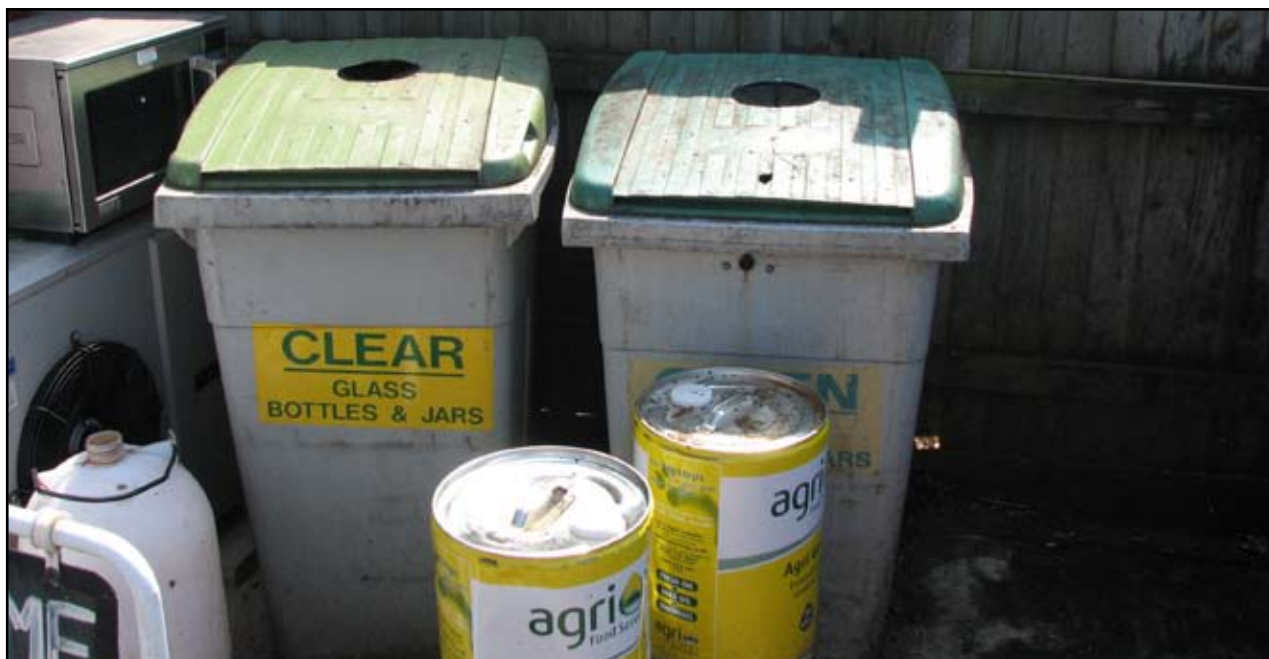
The club currently only recycle glass waste, all other waste is sent to landfill. The club should look to increase the number of waste streams that are segregated and recycled to help reduce their carbon footprint.

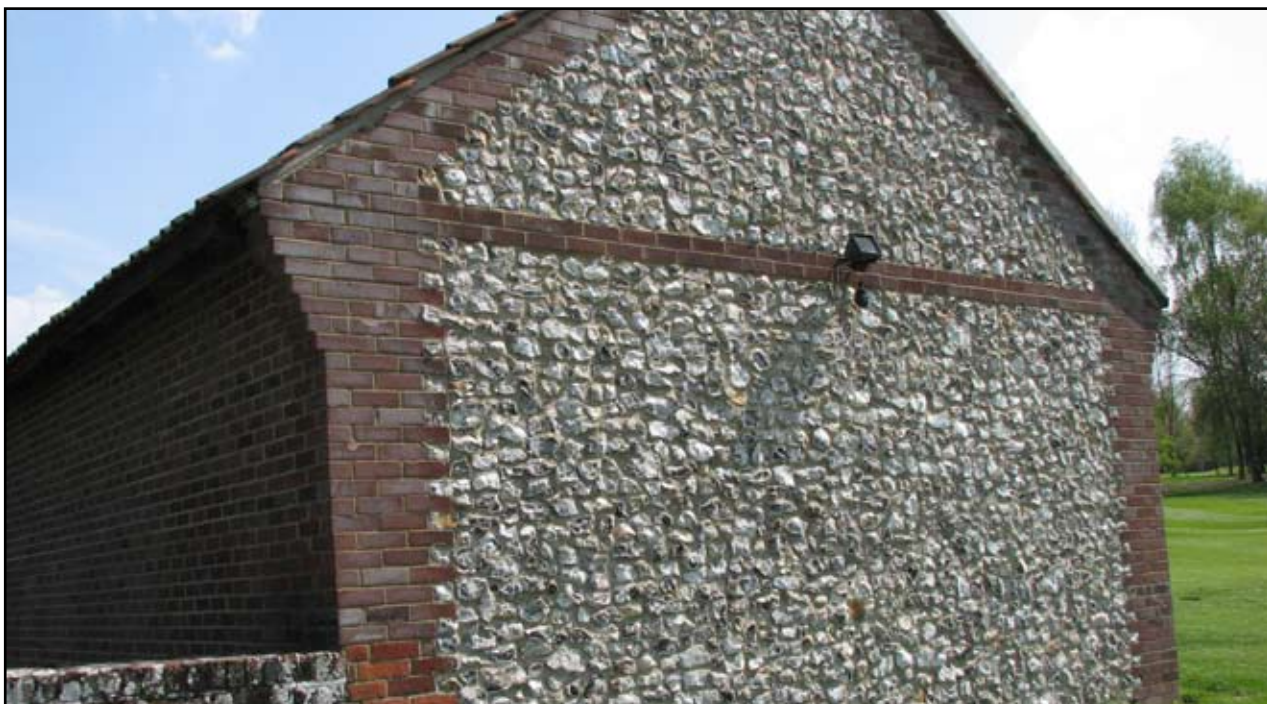
Curly's barn is an historic brick and stone built barn located away from the clubhouse within the golf course. This building is used to store machinery which is infrequently used on the golf course and also houses the irrigation system for the course. Six 100w fluorescent strip lights are provided within the building but these are used very infrequently and switched off when not in use. The irrigation system uses a significant amount of energy each year and this is discussed in Section 6.2
