# CARBON FOOTPRINTING AND ENERGY EFFICIENCY AUDIT

## Conwy Golf Club

**JANUARY 2010**

Kelly Harmar & Richard Stuttard  
Ecology & Environment

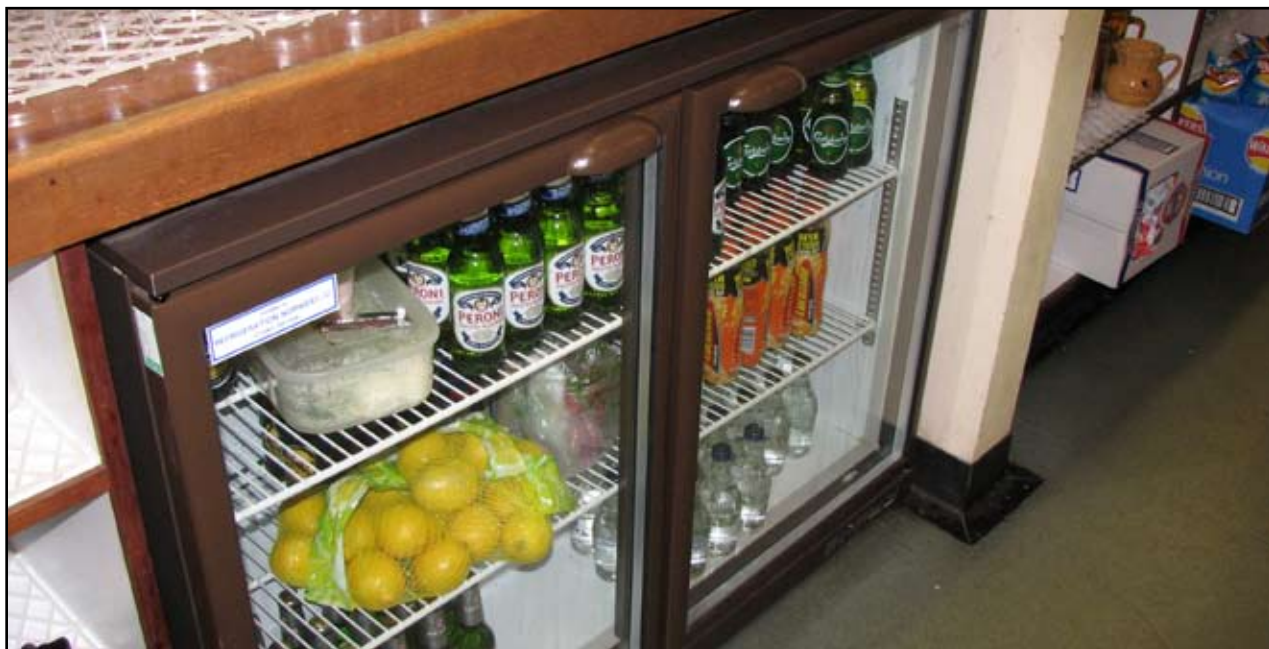
There are a number of ring and spotlights in the bar area and these should be replaced with more energy efficient varieties. Lighting in the bar alone currently costs the club approximately £752 per year. The installation of LED lighting could potentially reduce this figure tenfold.

| Issue | Solution |
|---|---|
| Halogen spotlights currently fitted | Install LED lighting |

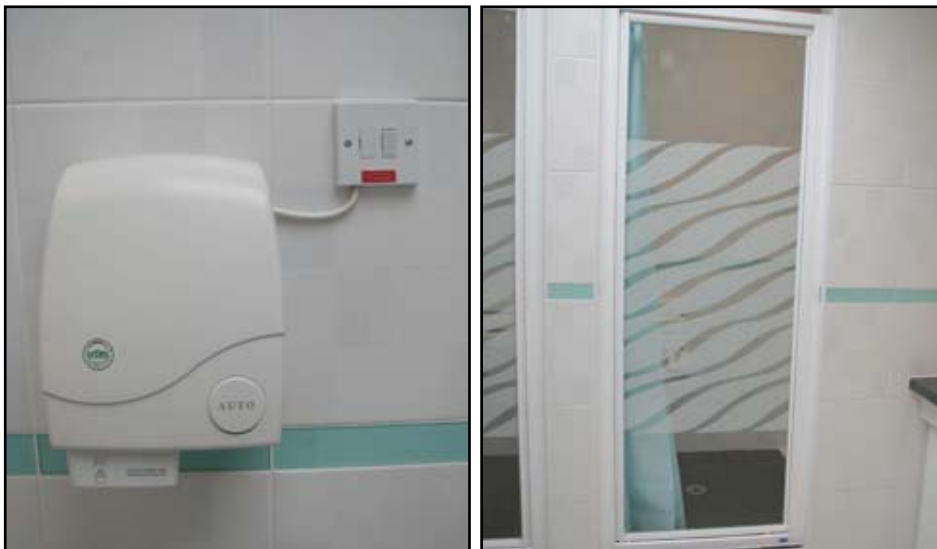
The 8 showers provided at Conwy cost the club an estimated £6000 per year. Highlighting this to the membership/visitors through signage and perhaps web notifications and encouraging the length of showering to be kept to a minimum would help reduce the considerable financial burden of these appliances

| Issue | Solution |
|---|---|
| Showers demand considerable amounts of energy | Educate users and encourage length of showers to be kept to a minimum |

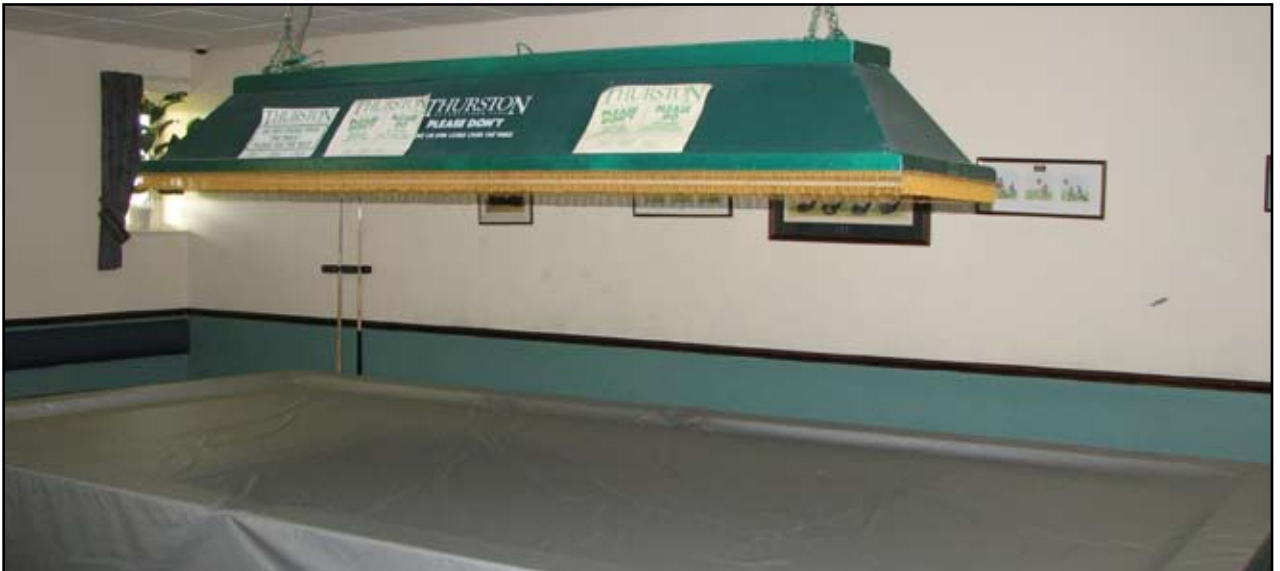
The snooker room at Conwy Golf Club was not being used on the day of STRI's visit. Despite this the room was being heated to an excessive temperature of 22°C. Given the sporadic usage of the snooker room this area should be kept at a relatively low temperature until in use at which time heating can then be increased.

| Issue | Solution |
|---|---|
| Heating left on when rooms not in use and room heated to excessive levels | Ensure thermostatic radiators are switch off unless room is to be used. Assign responsibility for this. Reduce thermostat setting |

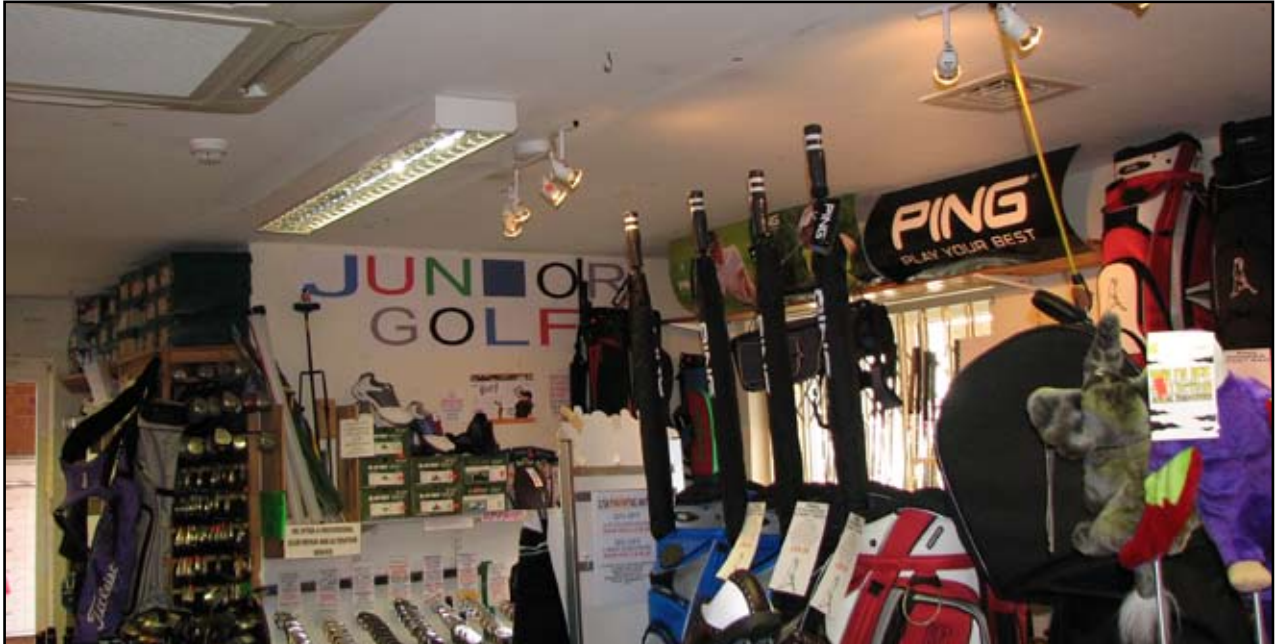
During the onsite inspection it was noted that a number of pieces of equipment were left on or on standby when not required within the pro's shop. Items such as the television and DVD player should be switched off at the mains when not required.

| Issue | Solution |
|---|---|
| Large amount of electrical equipment – much left on when not required | Ensure all equipment is off at mains when not in use. Assign responsibility |
