# CARBON FOOTPRINTING AND ENERGY EFFICIENCY AUDIT

## Woodhall Spa Golf Club

**Produced on Behalf of The R&A, EGU and GUW**

**JANUARY 2010**

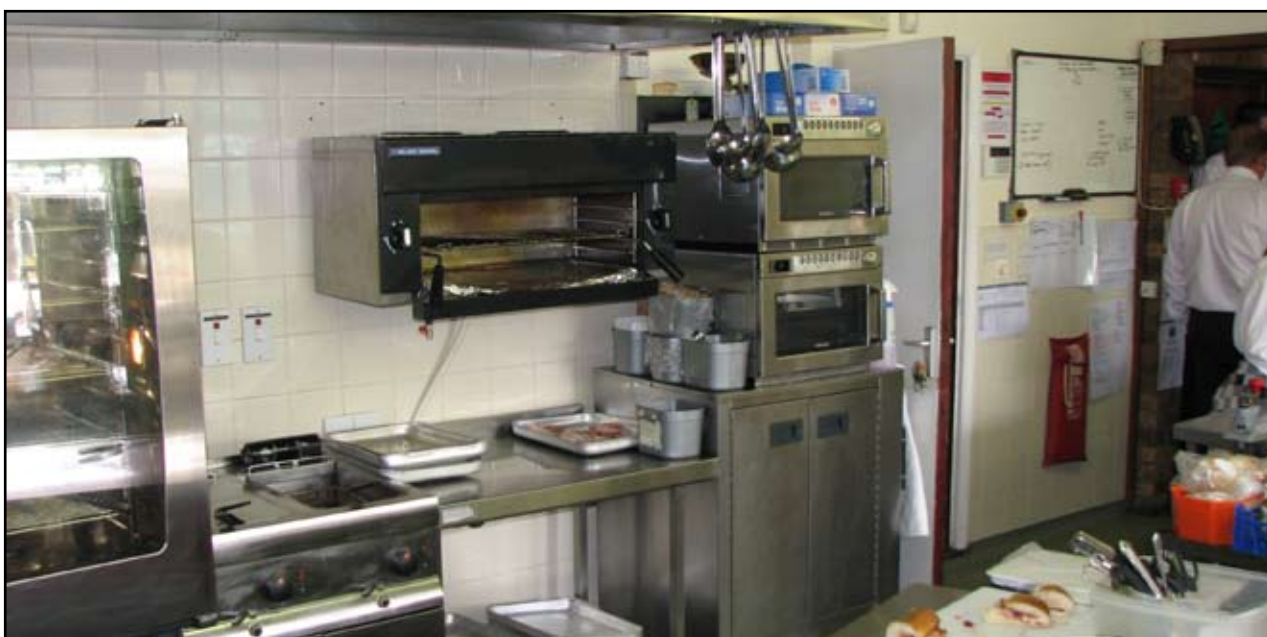
It is, of course, essential that appliances such as fridges and freezers are left on 24 hours a day and whilst there can be no compromise with operating times, it should be recognised that new versions of these appliances will be considerably more energy efficient than those aged five years or more. This comment applies to all equipment within the kitchens at Woodhall Spa and is perhaps most applicable to the club's washing machine that appeared to be in excess of 20 years old.

The kitchen at Woodhall Spa Golf Club leads to a network of side offices. During STRI's visit to the club the general observations made in this area were that lights were left on in many of the storerooms and side offices when vacant and of particular note was the radiator in the staff locker room (a room which is only briefly utilised each day) which was constantly delivering heat and maintaining the room at an uncomfortable temperature. In addition to this, the food storage room adjacent to the staff locker room was being air conditioned and kept at a very low temperature. Only an ill-fitting wooden door separated the two rooms and, as such, the radiator in the staff locker room and the air conditioning unit in the food storage room were competing with each other and therefore demanding more energy.

Radiators were also found to be left on in a number of the offices to the back of the kitchen area and it was also noted that a number of spider burners were left running throughout the day rather than being turned off and relit when required.

| Issue | Solution |
|---|---|
| Some appliances are dated and consume large amounts of power | Replace ageing appliances with new energy efficient models. |
| Heating on when rooms unoccupied and during periods of hot weather | Regularly monitor and adjust heating settings to meet the minimum needs required.<br>Give someone the responsibility of heating monitor. |
| Food storage room air conditioned yet adjacent to over - heated locker room. | Fit better insulated door between the two rooms and turn heating and air conditioning down to minimum required levels |

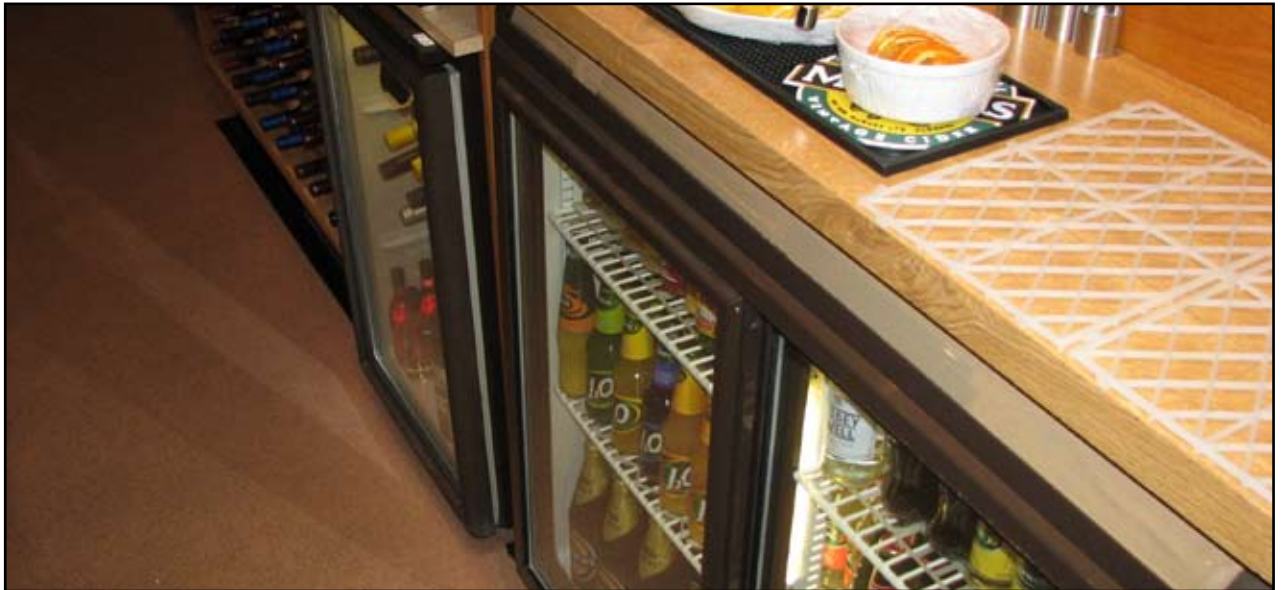
There are a total of four fridges within the bar and beer cellar area plus a main beer cooler unit which requires a constant 418.3 watts of electricity. It is presumed the bottle fridges are left on overnight. There is potential to fit timers to the fridges which will allow them to be off during the night (between perhaps 12am and 7am) yet back on early enough to ensure drinks are cold in time for bar opening. It is estimated that this would result in a saving of approximately £40 per year.

| Issue | Solution |
|---|---|
| Bottle fridges left on 24 hours a day | Fit timers to ensure fridges are only on when required. |

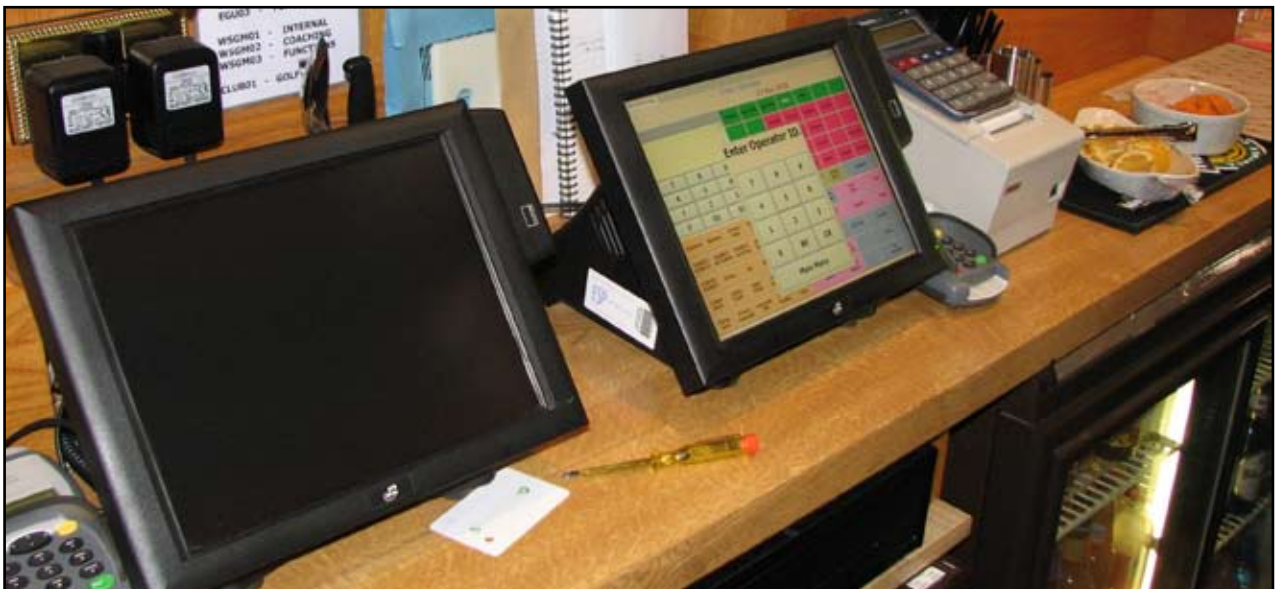
In addition to natural light from the skylights, the bar area is lit by 14 halogen spot lights estimated to be costing the club £270 per year. Replacing these with low energy LED bulbs would reduce this figure ten-fold.

All electrical equipment that is only required during opening hours, including tills, Sky box, card reader and receipt printers should be switched off at the mains when not in use. To highlight the cost of such appliances, the two tills, if left switch on 24 hours a day, cost the club the not inconsiderable sum of £367.14 per year.

| Issue | Solution |
|---|---|
| Equipment left on or on-standby when not in use | Turn equipment off when not in use.<br>Employ "switch me off" stickers as reminders |
| Halogen spotlights currently fitted | Fit energy efficient bulbs |

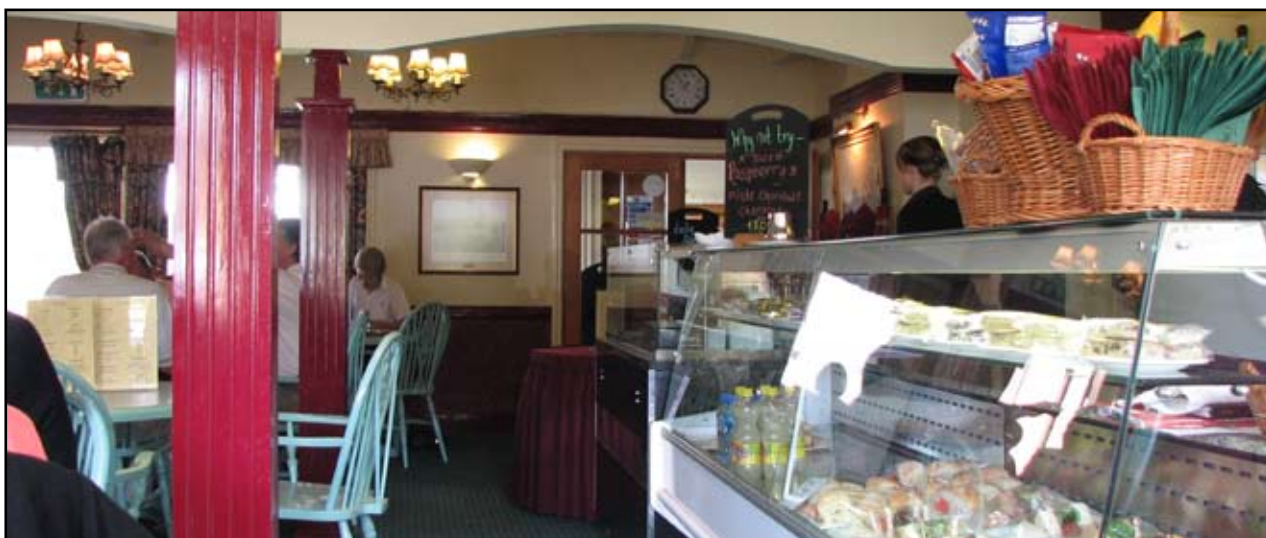
A number of high energy appliances are used in the dining area including the "hot cupboard" which demands 2.2kW of electricity to function, a hot water boiler and display chiller. These appliances should only be on when necessary. The hot cupboard should only be required during peak meal times.

| Issue | Solution |
|---|---|
| Equipment left on or on-standby when not in use | Turn equipment off when not in use.<br>Employ "switch me off" stickers as reminders |

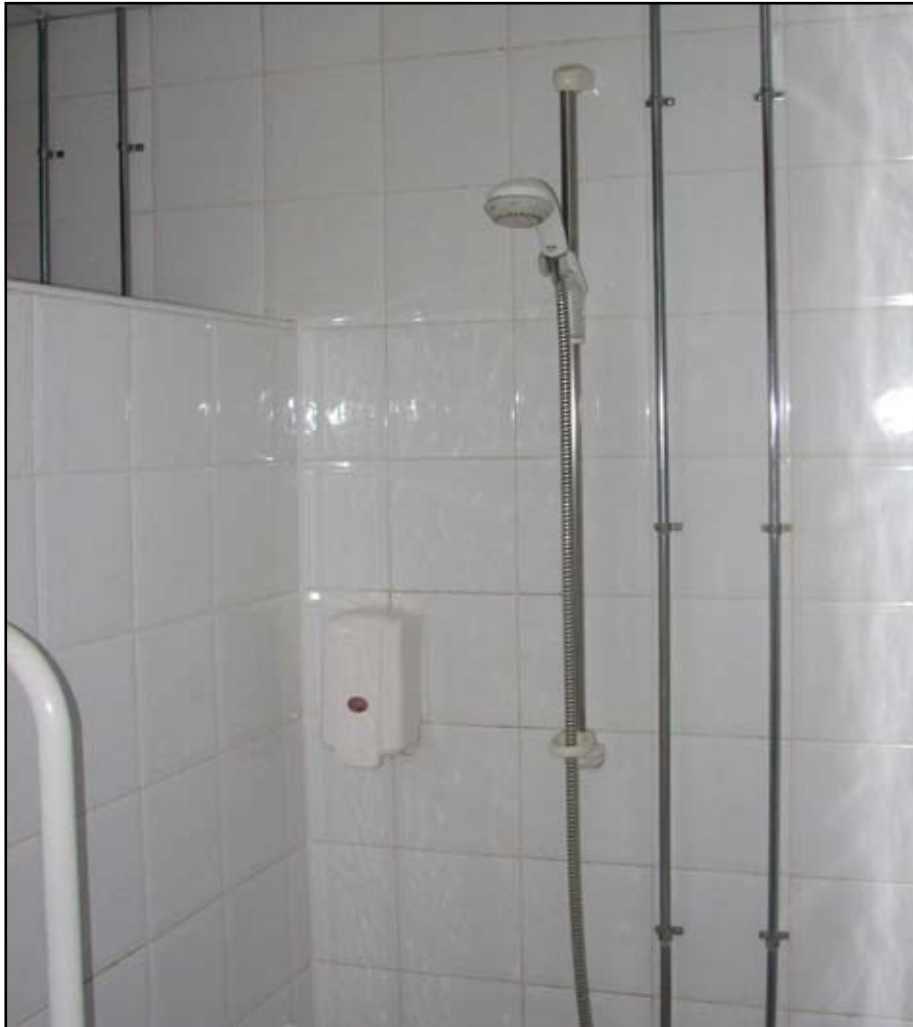
The electric showers provided in both the ladies and gentlemen's locker consume a vast amount of energy and are estimated to be costing the club £3,028 per year. Highlighting this to the membership thorough signage and perhaps website notifications and encouraging users to keep the length of their showers to a minimum could significantly reduce the financial burden of these appliances.

| Issue | Solution |
|---|---|
| Showers are hugely energy demanding | Educate members and encourage minimal usage |

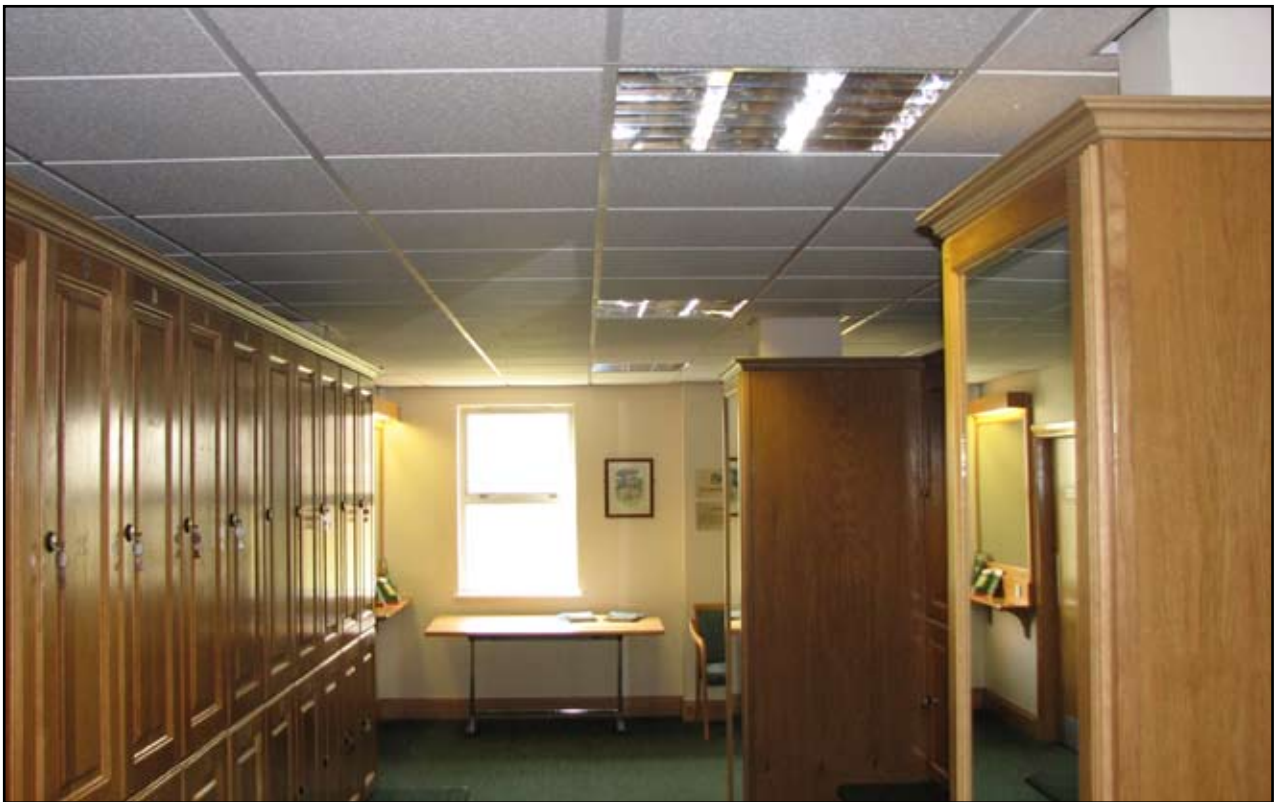
The new building has the benefit of double glazing, thereby vastly improving its insulating properties. It was still the case however that lights were left on when the room was vacant and heating was on at an unacceptably warm level. This was particularly noteworthy given the warm outdoor temperatures of the day. All thermostatic radiators were noted as being set to their maximum level.

Lighting above mirrors was also left on when not in use. Given the close proximity of the mirrors to windows these lights are unnecessary during daylight hours and should therefore be able to be activated independently of the main lights.

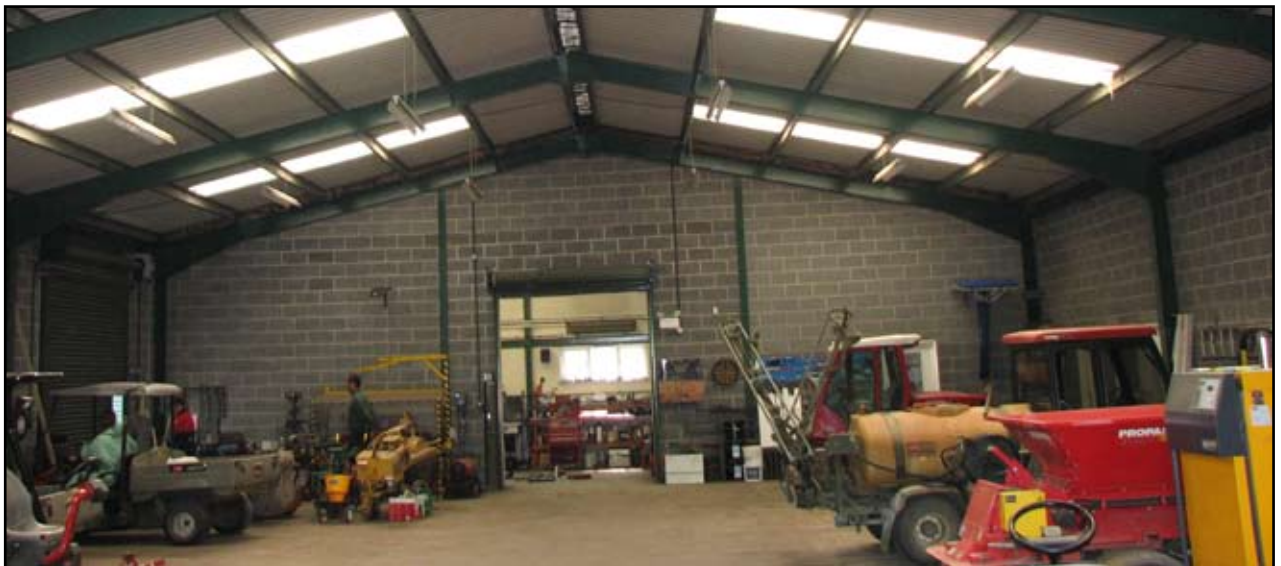
The compound is heated by a wood burning stove but also has central heating installed within office areas.

Lights have differential controls however lighting was noted as being left on in the kitchen and offices when vacant. Motion sensors would be appropriate for these areas.

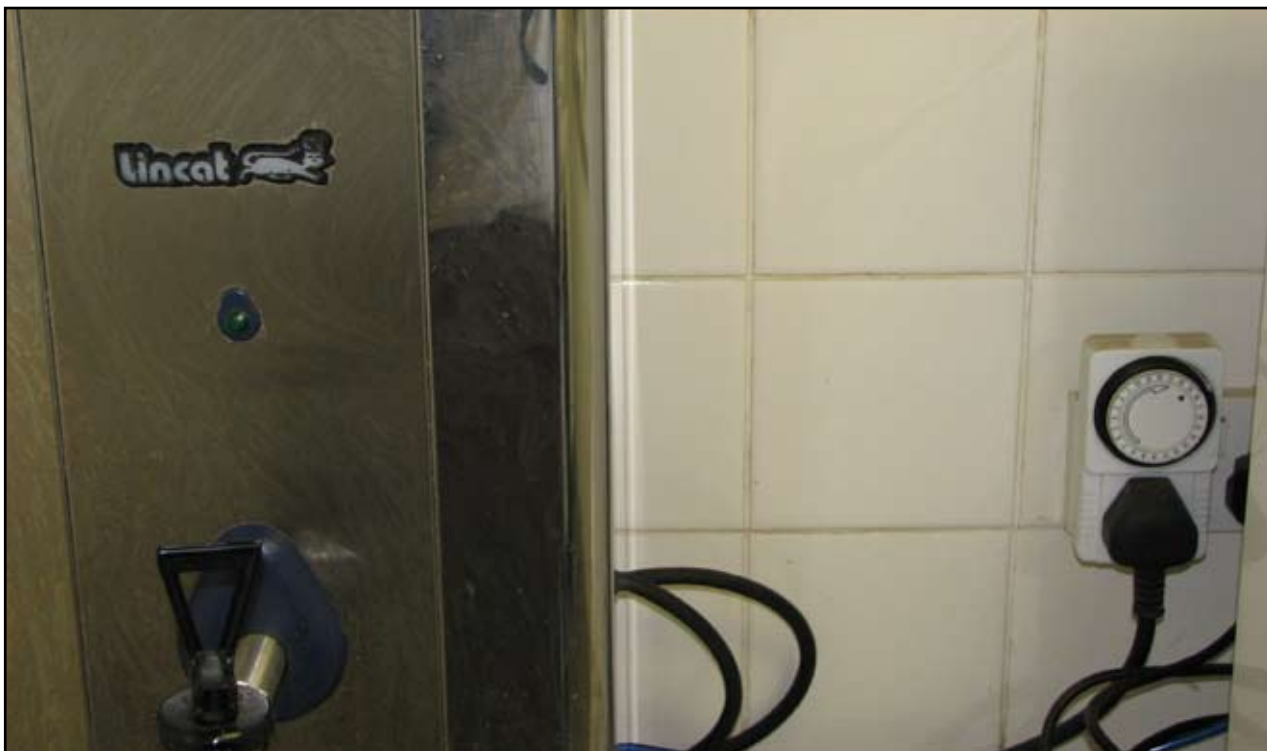
The kitchen area contains amongst other things two microwaves a dishwasher and two toasters. There is also a water boiler which was noted as being connected to a timer. This is a very positive initiative although it was noted that the timer was set to switch the boiler on at 2am – which it is felt is a little premature.
